USM-EXHCV-26/08
FORD CARGO
PRODUCT IMPROVEMENTS
&
SERVICE ACTIONS AND
RECOMMENDATIONS

Updated
31/08/2008

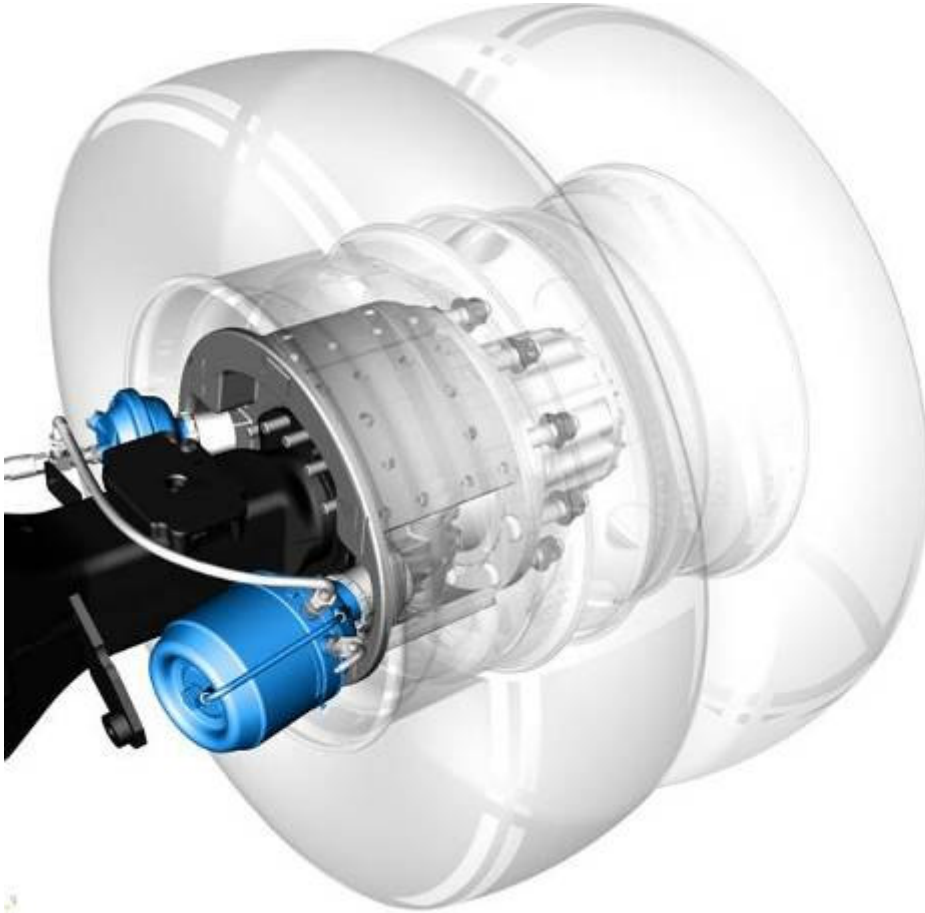
SPRING BRAKE CHAMBER QUALITY PROBLEMS

Problem: Spring Brake Chamber Air Leaks

- Air leaks from service clamp
- Loose seal of bottom cap
- Air leaks from O-ring of upper cap

Action: Supplier quality improvements

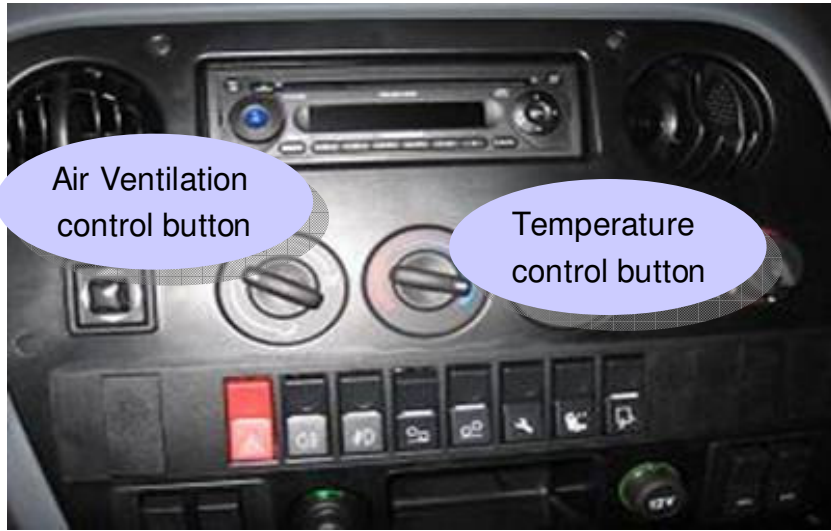
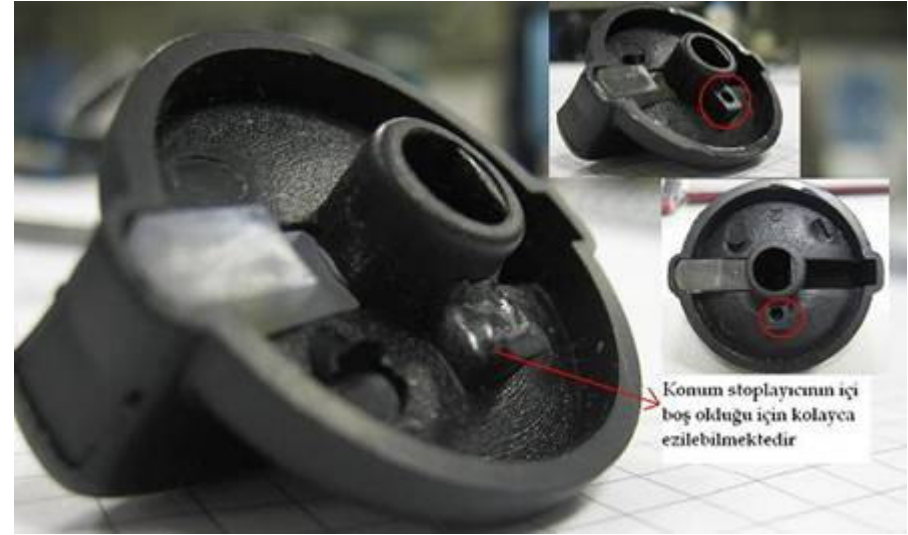
HEATER CONTROL BUTTON

Problem: Tooth Grazing of Heater Control Button

- Heater wire angle changed. Button operation effort decreased, starting with the vin : 64940

Improved part : **Heater Control Panel 3C46-18549-AD** Implementation date: **September 2007**

- Heater control button ring fitting and claw length increased. Button grazing torque increased to 5.5 Nm.

Improved part : **Control Button (SP) 7C46-18519-AA** Impl. date: **September 2007**

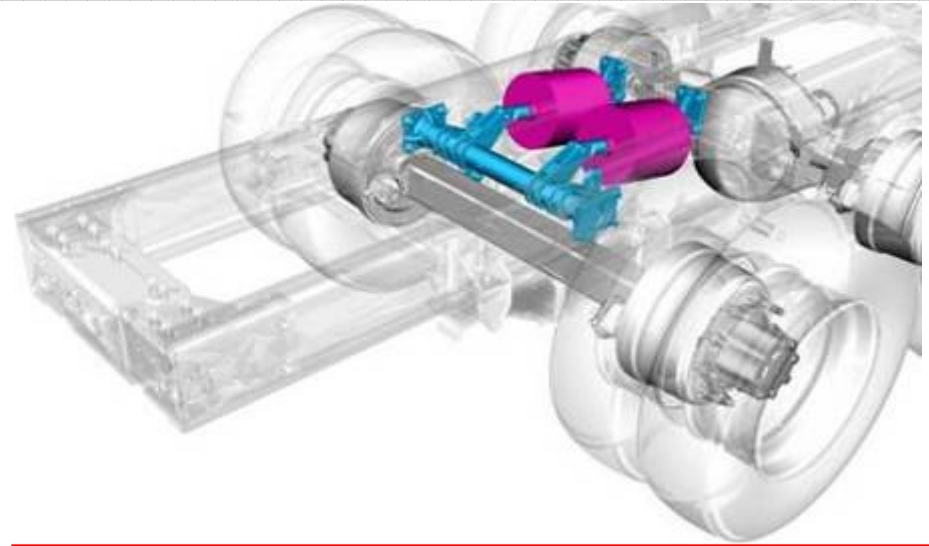
TAG AXLE LIFTING PISTON FAILURES

Problem : Supplier quality problems.

Root Cause : Part has been manufactured by two different suppliers.

Action : Problem part and manufacturer has been removed from production.

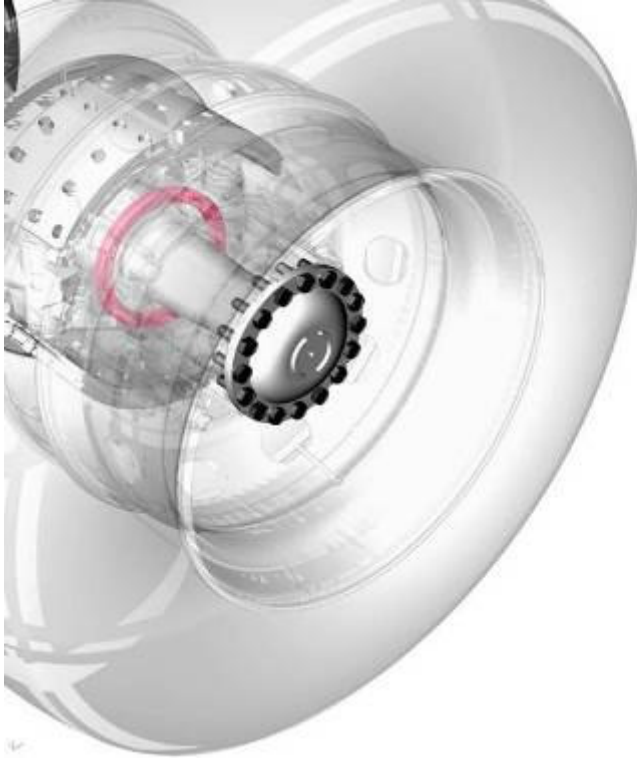
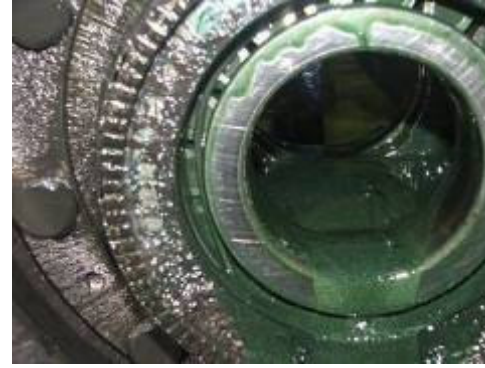
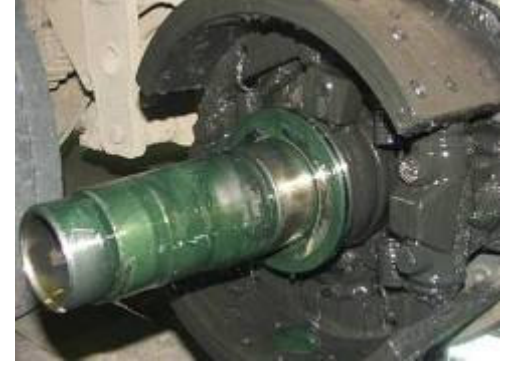
OIL LEAKS ON WHEEL HUB SEALS

Problem : Oil leaks on wheel hubs

Root Cause : Quality problems

Action : Viton brand oil seals, that are resistant to heat and differential oil, have been released except front wheels.

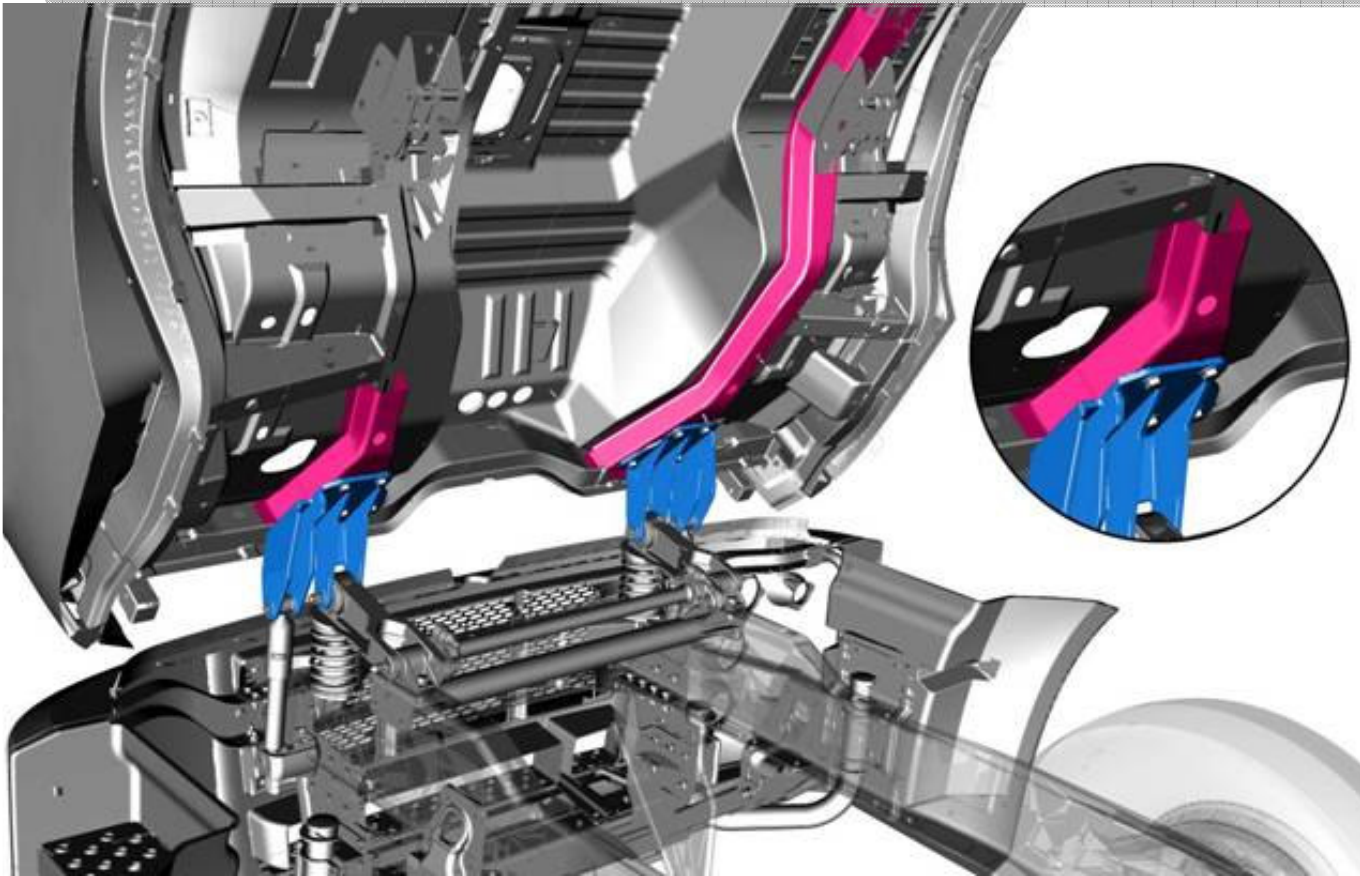
BREAKAGE OF CROSS BRACKET UNDER CAP

Problem : Cross bracket breakage under the cabin

Action : Internal areas of cab cross bracket reinforced and durability 500% improved.

External reinforcement bracket released for after sales :

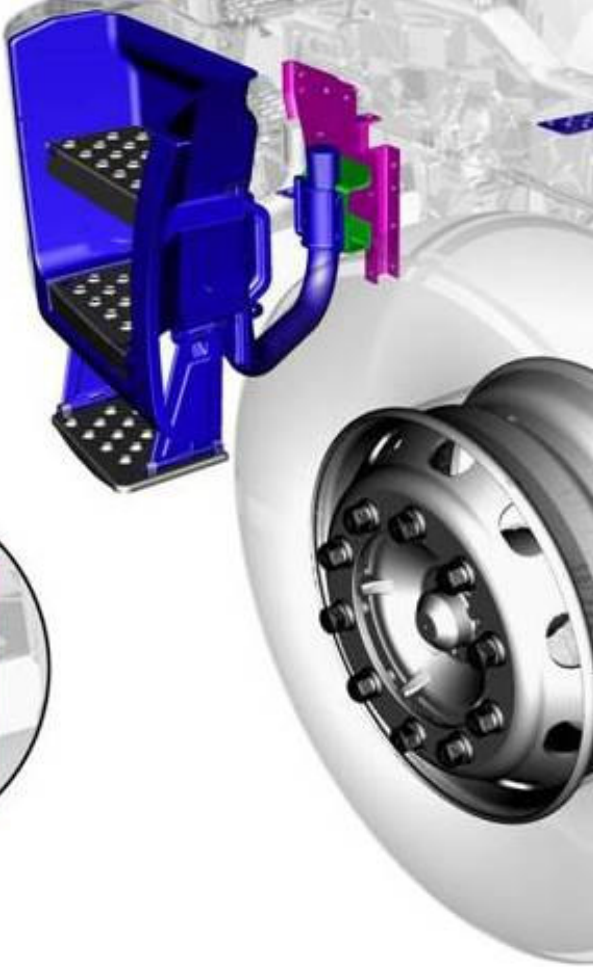
STEP BREAKAGE

Problem : Breakage of side steps because of excessive vibration and hardware quality problems.

Actions : Welding connections implemented for the bolt ruptured areas.

Rod connection between left and right step assemblies canceled.

Spring application has been implemented for the bottom step to prevent excessive vibration.

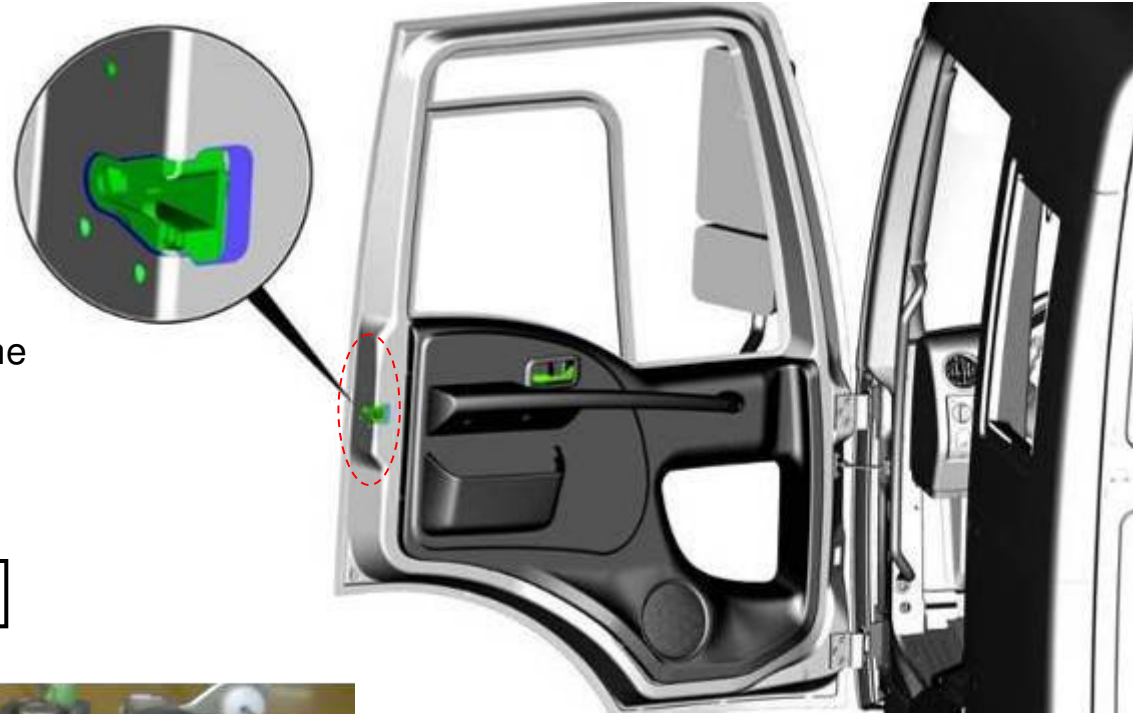
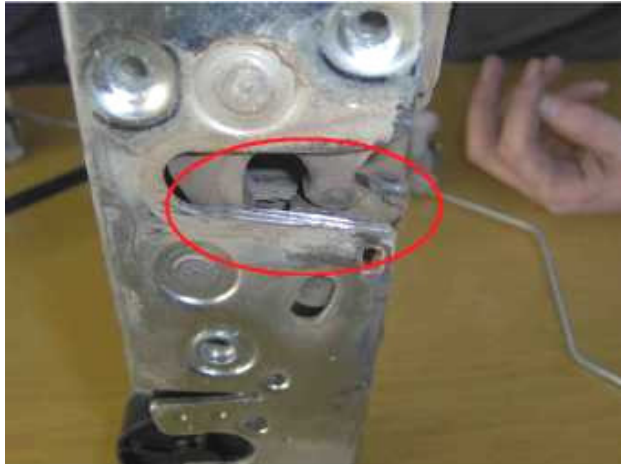
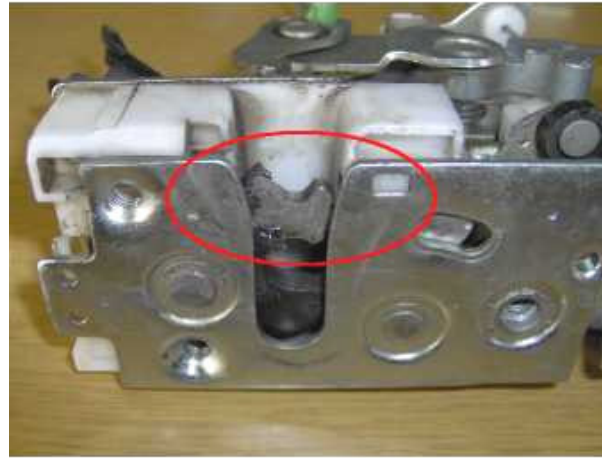
DOOR LOCK FAILURES

Problem : Malfunction of door locking mechanism

After locking, one or both doors can be unlocked by remote control.

Action : Revisions applied to minimize the gaps on latch location.

Inner door handle bezel has been revised to decrease the operation efforts.

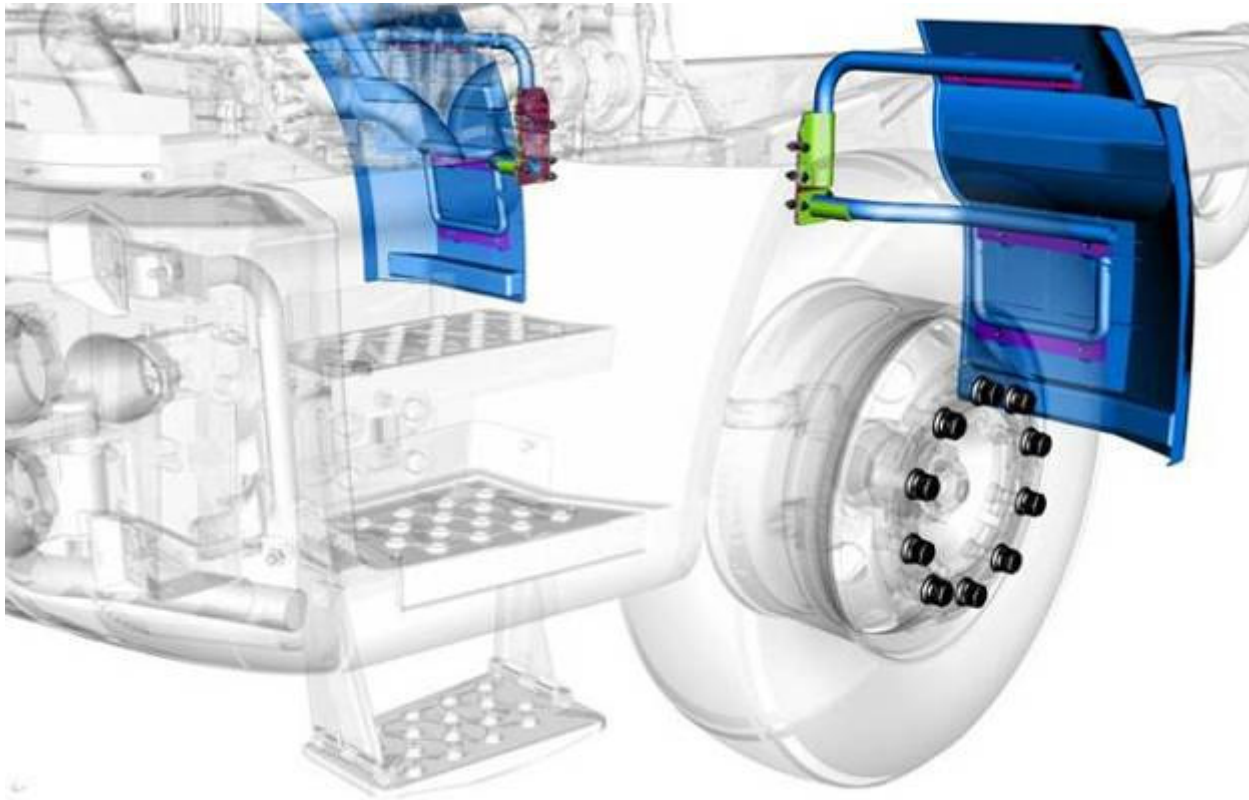
BREAKAGE OF REAR FENDER(CAP) AND ITS BRACKET

Problem : Breakage and cracking problem of rear fender and its bracket because of excessive vibration.

Action : 1) Rubber added to fender material and flexibility and endurance of the part increased breaking and cracking problem from attachment points eliminated.

2) Reinforcements added behind the body attachment brackets and welding process optimized.

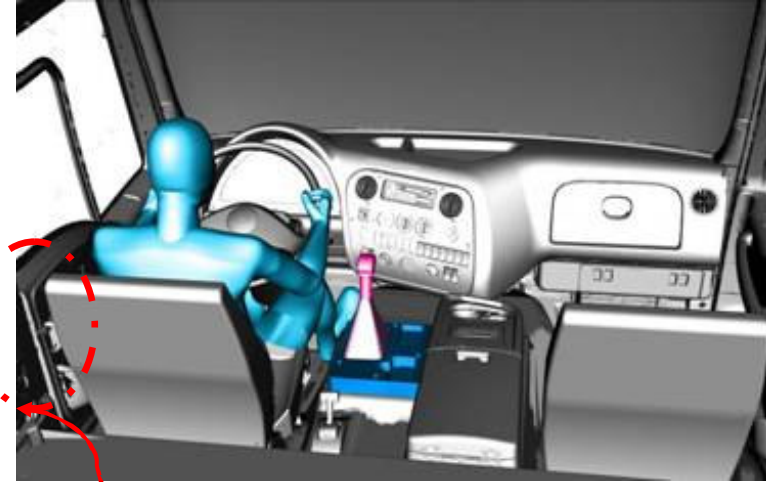
DUST INGRESS INTO CABIN

Problem: Dust ingress into driver's cabin

Actions : Pad installation on WEBASTO discharge point of damp trucks
Impl. Date: **May 2007** Vin no: **63330**

Gearshift area insulation provided by new gearshift lever.
Imp. Date: **December 2007** Vin no: **67586**

In order to prevent the dust ingress from the shifting mechanism, gear lever gaiter improved for the vehicles manufactured before the vin **67586**

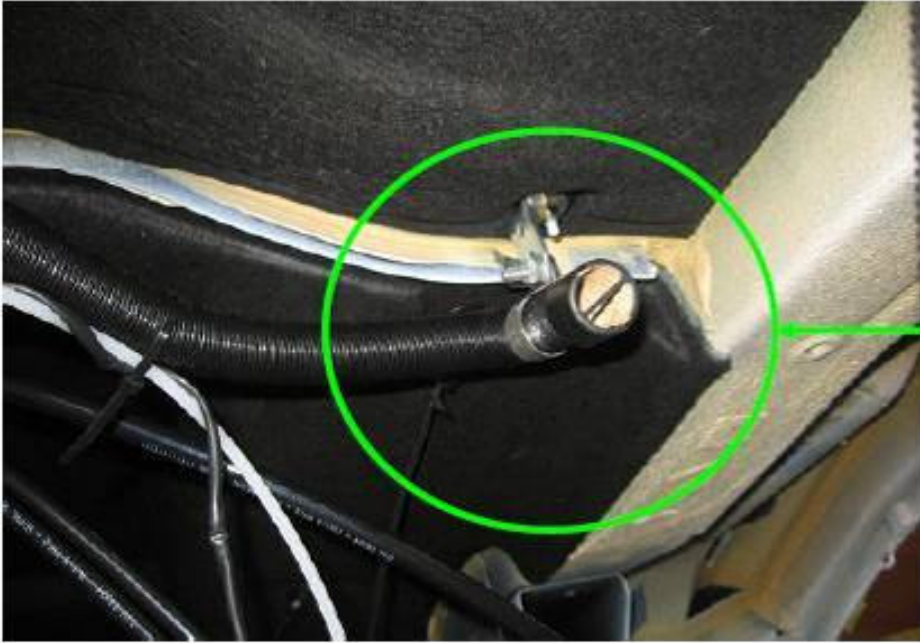
INSIDE CABIN HEATER – EBERSPACHER PROBLEM

Problem : Dust ingress into Eberspacher Cabin Heater motor on 7,3lt Cargo 240&300 PS vehicles

Root Cause: Incorrect part installation

Action : Clean air intake pipe of the heater, re-assembled to opposite position to driving direction to eliminate the problem

Clean air intake pipe routed opposite to the driving direction.

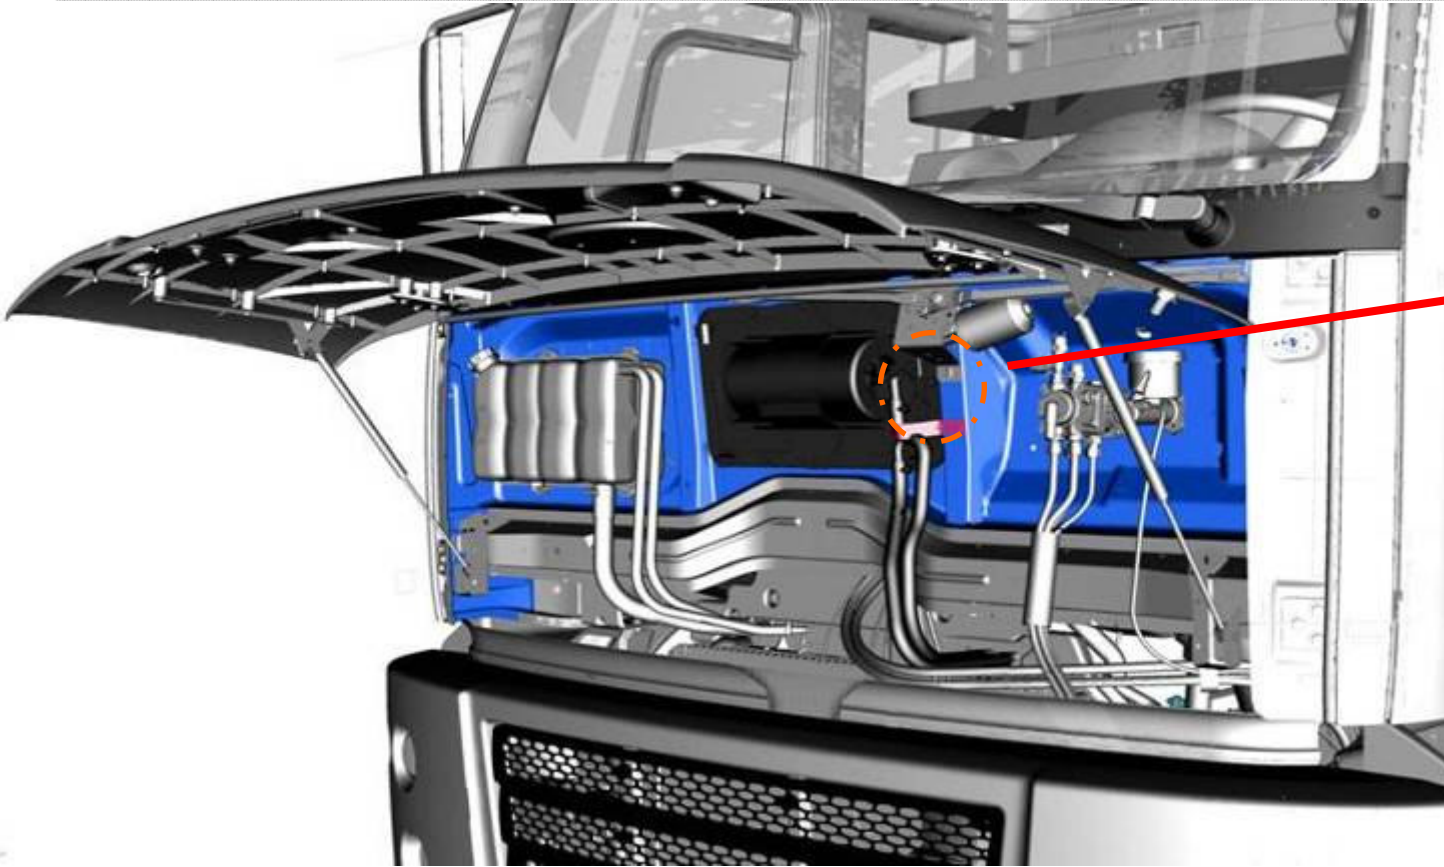
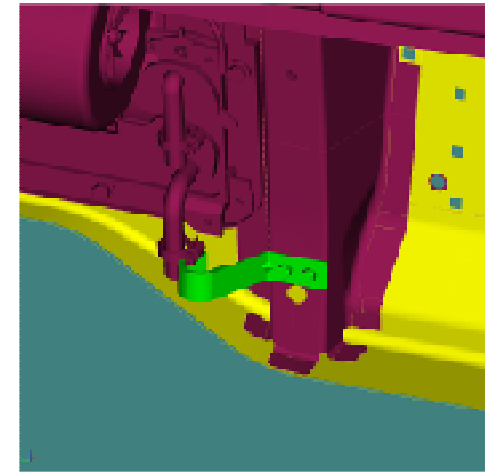
HEATER TAP PROBLEMS

Problem : Heater tap gets broken

Action : Bracket added to hose connection in order to eliminate the vibration

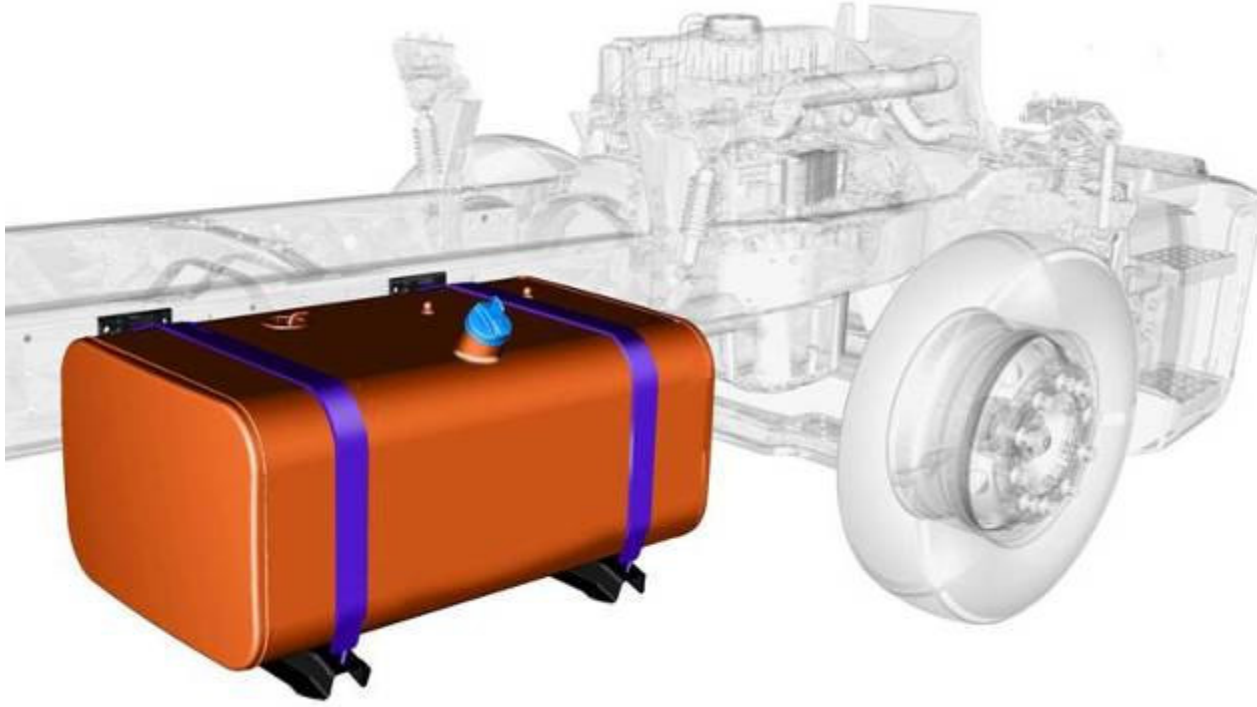
LEAKS ON FUEL TANK AND STRAP PROBLEMS

Fuel leaks on the side welding areas stopped by the convex cap fuel tank.

Strap torque increased to 46 Nm from 23 Nm and strap lengths adjusted.

Ventilated cap implemented instead of non-ventilated (ventilation was made by the filter).

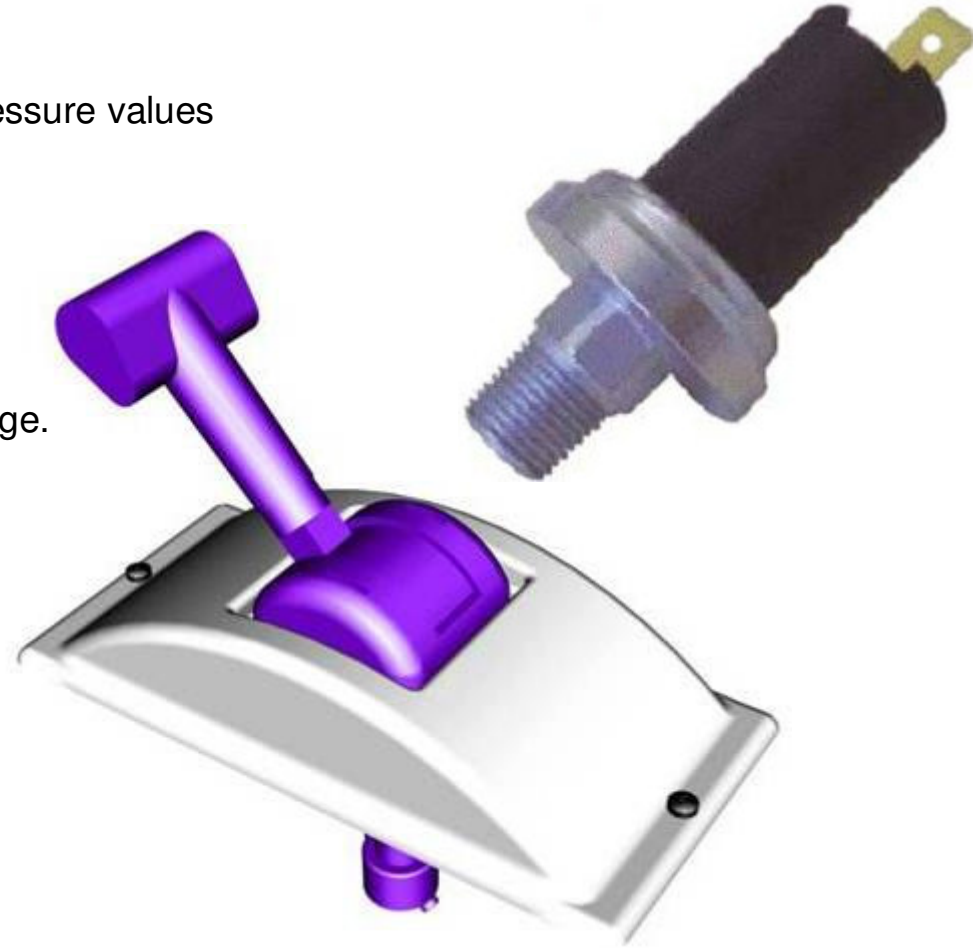
HANDBRAKE SENSOR QUALITY PROBLEMS

Supplier quality problems. Incorrect adjustment of sensor pressure values

From 20.12.2005 on 100% controlled brake sensors have been into production.

New brake sensor have been released by the supplier change.

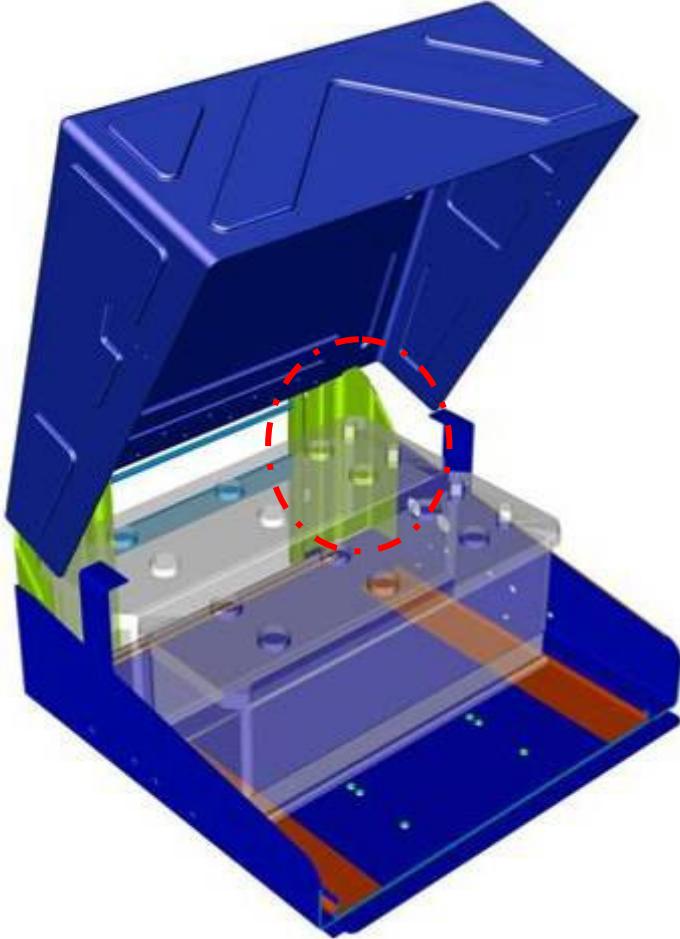
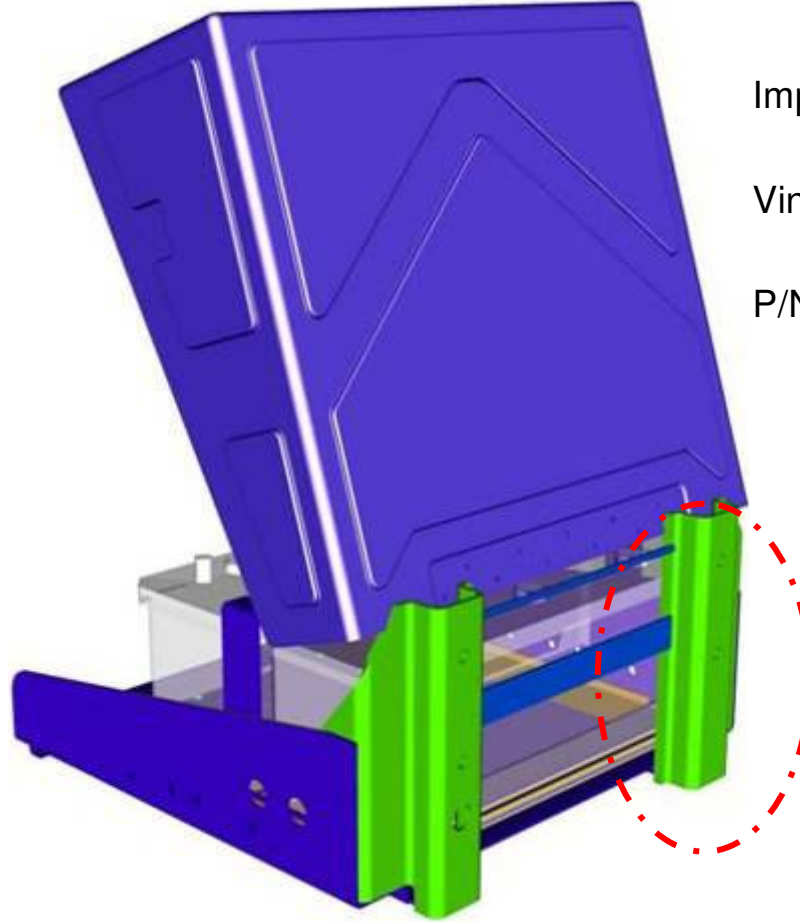
BATTERY TRAY BREAKS

Unique breakage or cracks on 180 Ah battery case brackets.

Thickness of battery connection arms and reinforcements have been increased.

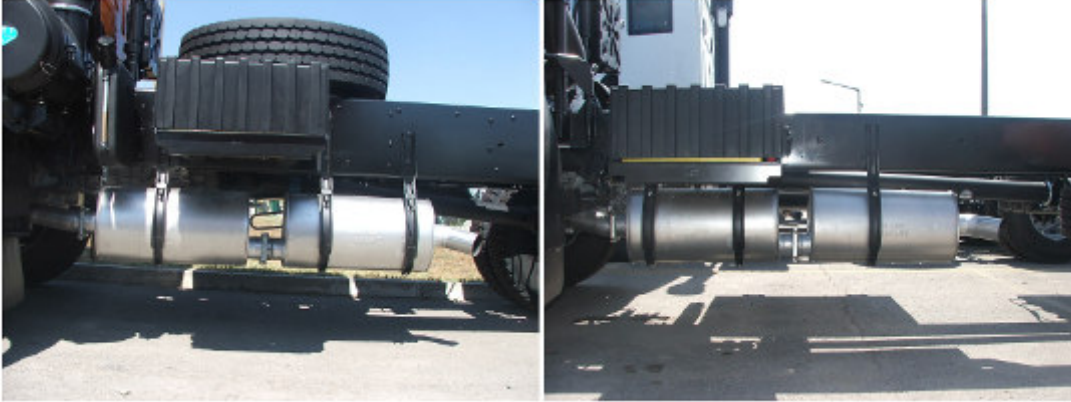
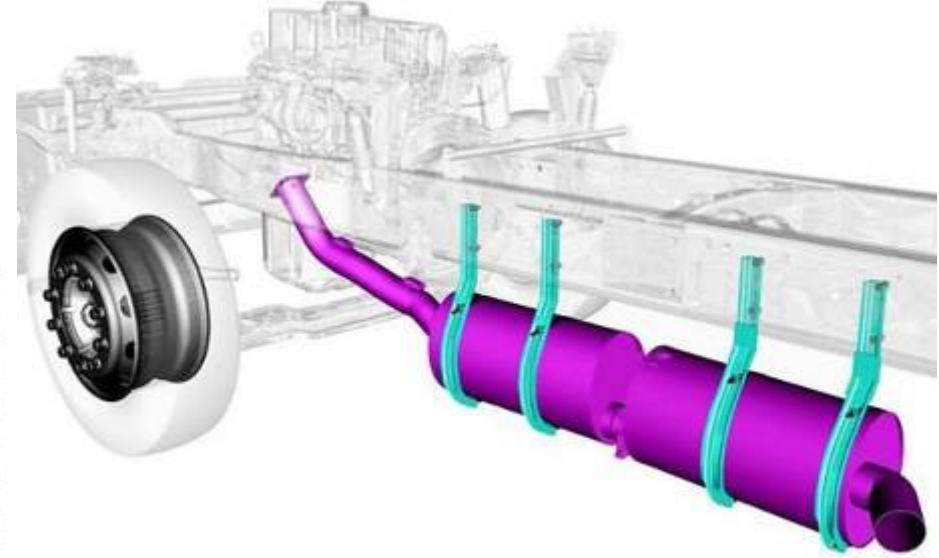
EXHAUST BRACKET BREKAGE ON EURO3

Due to the breakage problem of the muffler support brackets on EURO 3 vehicles, quantity of brackets have been increased to 4 from 3 units and the existing brackets have been revised.

- Deburring operation canceled on the bracket. 4th bracket added to all vehicles starting with the vin: **65164** except 1830. Impl. Date: **17.09.2007**
- Material change done on improved brackets and yield strength increased starting from the Vin : **66463**; Impl. Date: **1.11.2007**
- 4th bracket implemented on 1830 vehicles. Vin: **68595** Impl. Date: **08/02/2008**

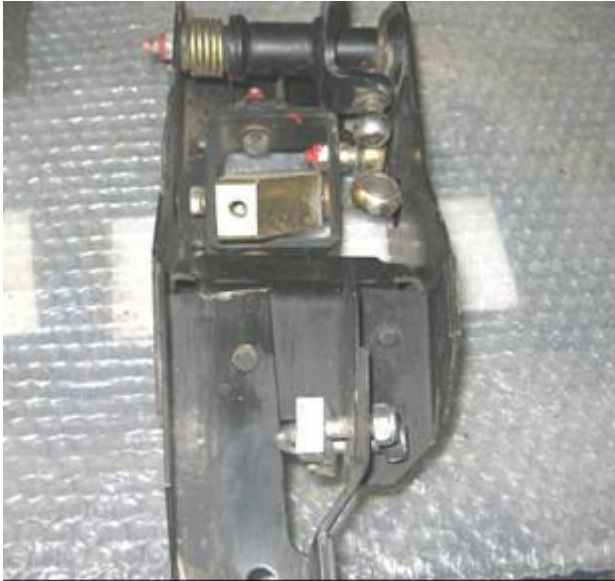
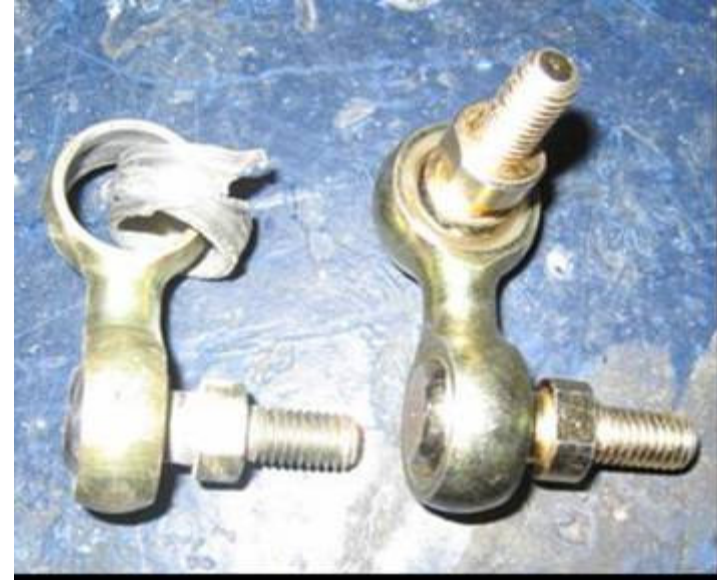
GEARSHIFT MECHANISM JOINT PROBLEMS

Joint breaks of gearshift mechanism; problem can be fixed by replacing a joint instead of complete assembly .

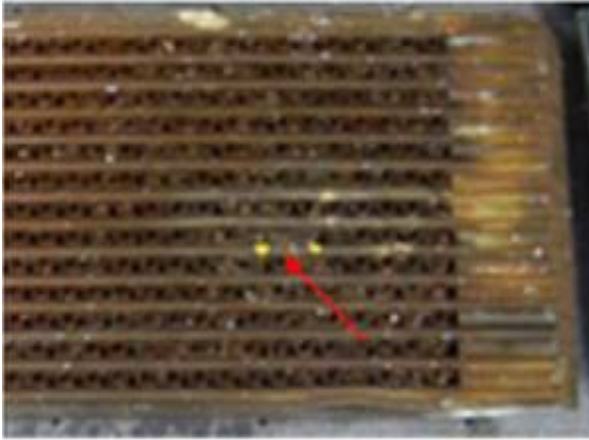
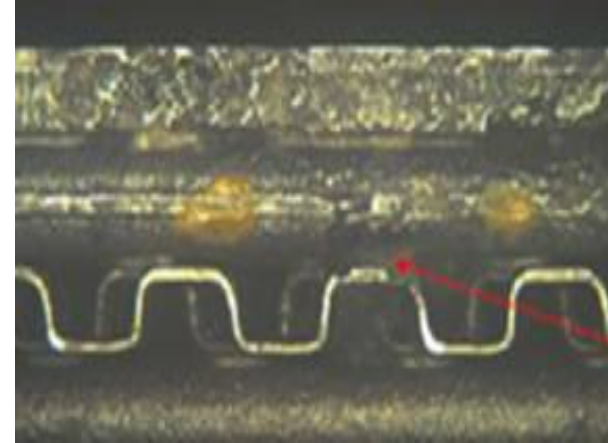
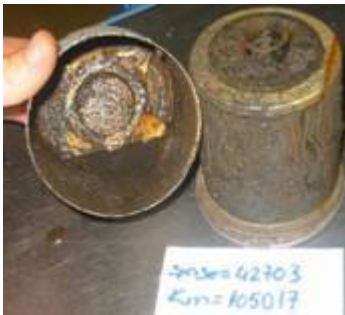
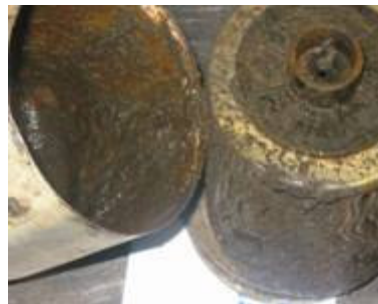
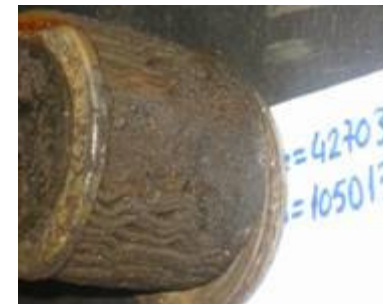
OIL COOLER FAILURES

Perforation in oil cooler, oil-water mixture , root cause and repair actions:

No usage of Cooling liquid / no usage of recommended coolant liquid :

Wear in water carriers by the particles inside:

Coolant liquid (anti-freezer) should be absolutely put into coolant water.

Water filter - previously being replaced in every 100.000 km, should be replaced firstly in 2.periodical maintenance and then in every following 100.000 km with 986T 8T502 A1B.

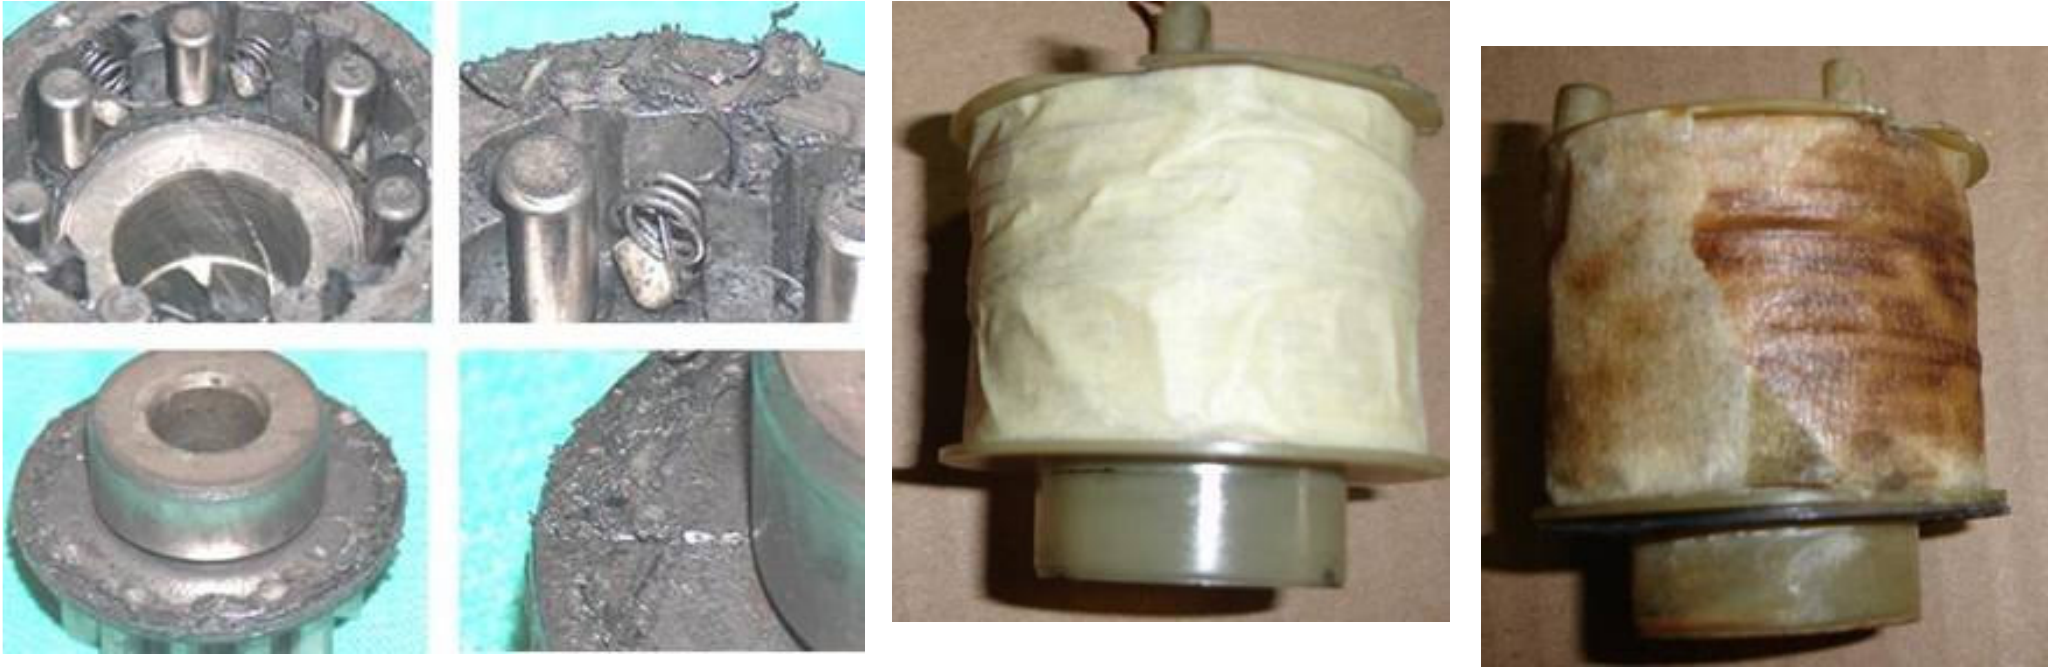
STARTER MOTOR FAILURES

Starter motor failures:

- Puncture and oil leaks on plastik protective cover.
- Deformation of spring and ball bearings in clutch.
- Burning of the coil wraparound.

- Before starting the engine, handpump of fuel filter located on the chassis should be operated by customer until feeling the opposite fuel pressure.
- Users should be warned to prevent from longer ignition period. Refer to Users Manual.

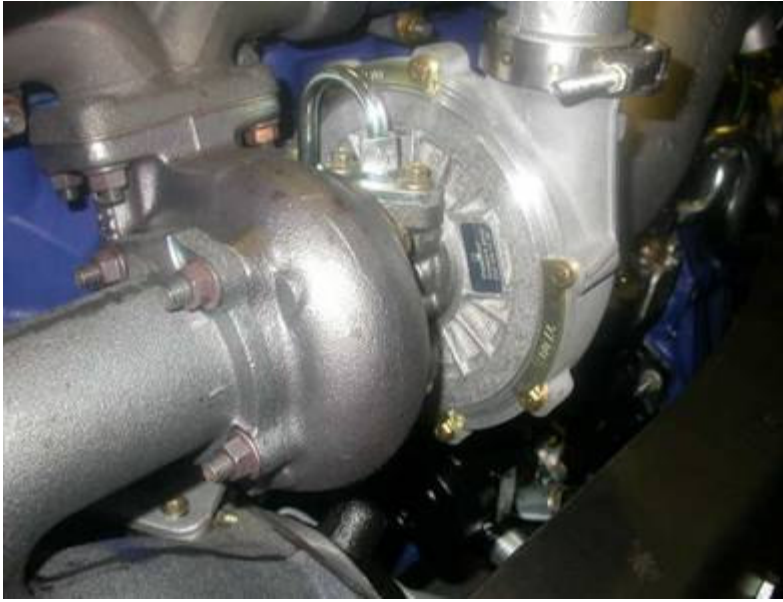
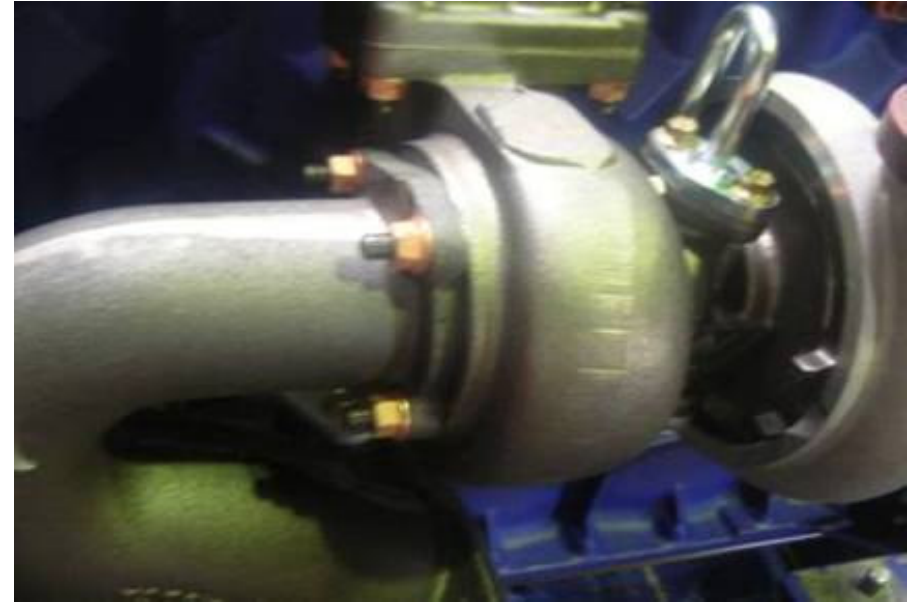
TURBOCHARGER FAILURES

Turboshaft bearing and turbowing damages:

- Piece from air filter ruptured by the turbocharger because of dirty and choked filter.
- Over-heating on turboshaft – to stop the engine on high rpms.
- Irregular oil replacement intervals.

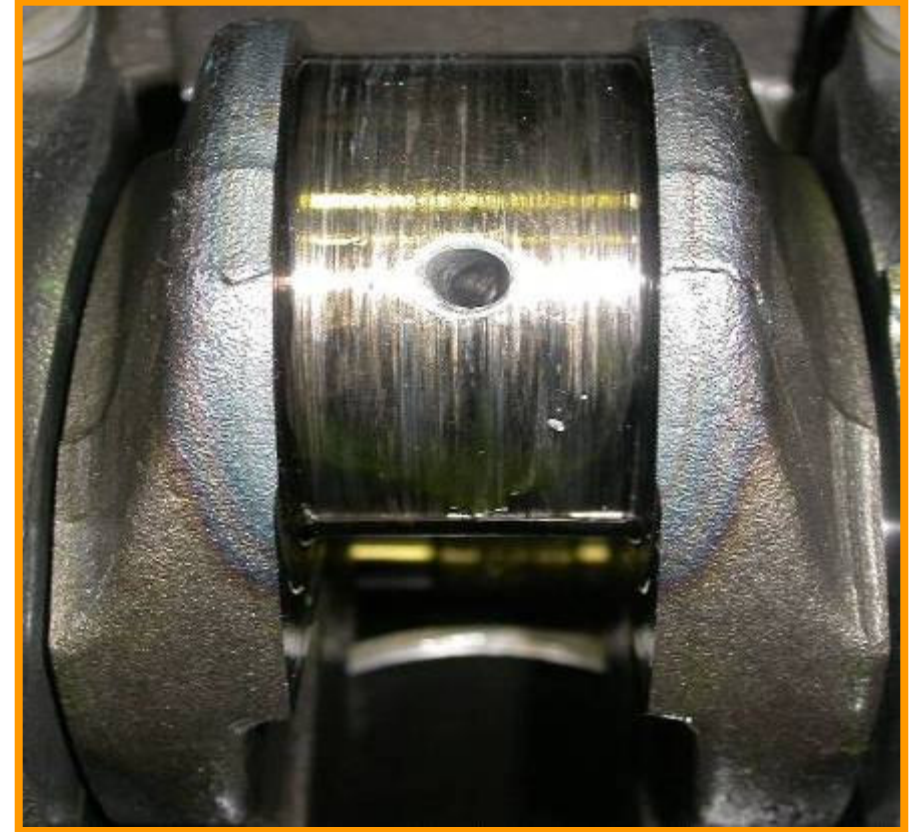
PISTON BEARING FAILURES

Root causes of connecting rod bearing failures:

Overspeed: Should be checked by EDS and the failure ECU code.

Irregular Maintenances : Oil and filter replacement intervals should be checked if performed in required intervals.
