USM-EXHCV-26/08
FORD CARGO
PRODUCT IMPROVEMENTS
&
SERVICE ACTIONS AND
RECOMMENDATIONS

Updated
31/08/2008

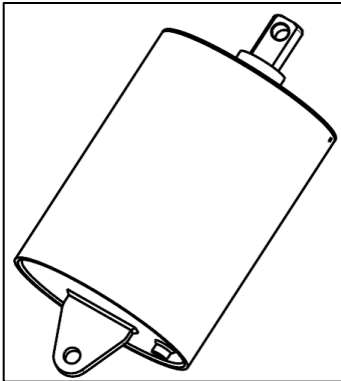
TAG AXLE LIFTING PISTON FAILURES

Problem : Supplier quality problems.

Root Cause : Part has been manufactured by two different suppliers.

Action : Problem part and manufacturer has been removed from production.

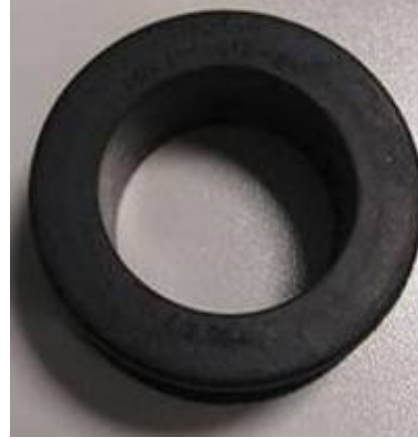
95CT 14612 BA GROMET

Gromet application implemented on 3230S vehicles, to prevent the Hendrickson axle lifting bellow punctures by touching to assembly hole on the bellow plate on S-axle .

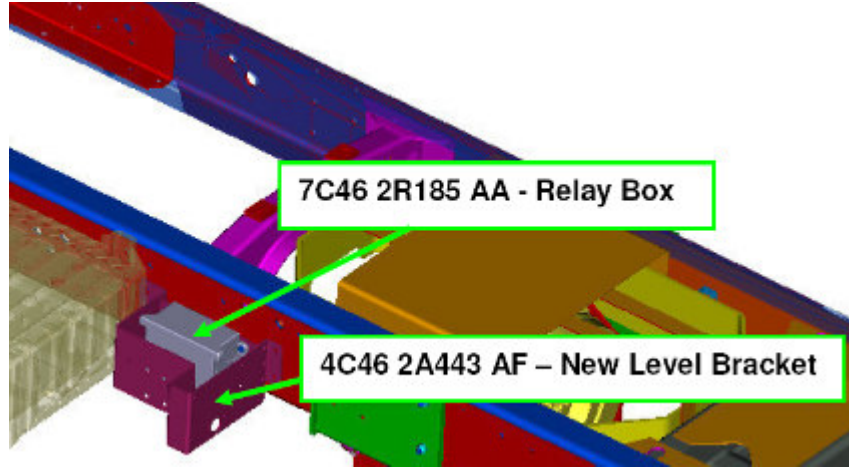
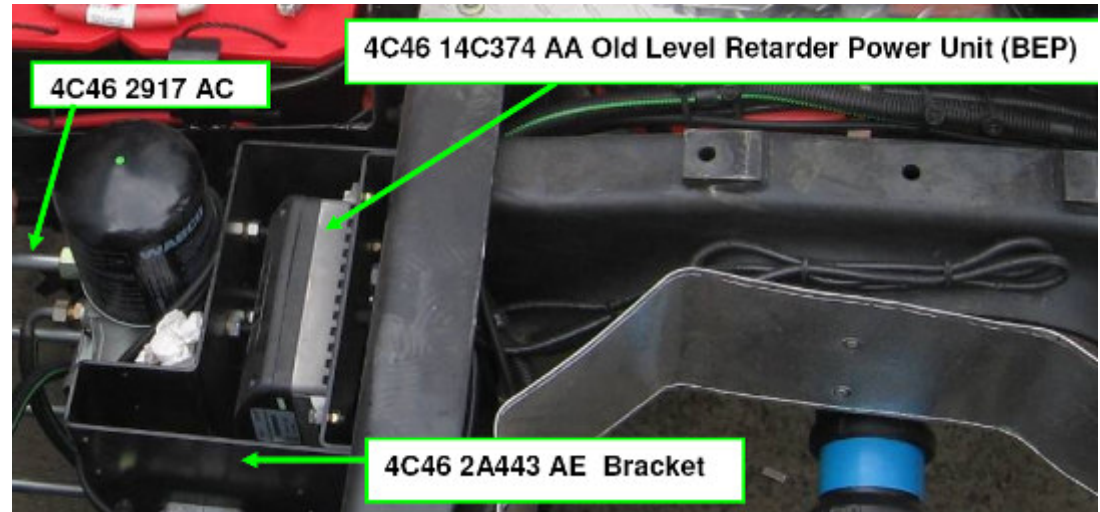
In case of a problem on **3C46 14C374 AA Retarder Relay Box** service instructions in the **TSB-TRHCV-17/2008** should be performed and new level retarder power box should be assembled with the below parts.

New Relay Power Box Part no: **7C46 2R185 AA**
